#### PREFACE

publication Design Consideration Briefs was compiled in the thesite These to highlight some design considerations which have or could jeopardize the safety of personnel and equipment. The Briefs should be of special interest to the designer who does not have the opportunity to keep himself well informed on current operational and maintenance concepts and problems associated with missile systems. If industry and government agencies' response is favorable to the usefulness of this document, action will be taken to assure periodic publication of pertinent Design Consideration Briefs. To assist in the follow-on evaluation special attention is directed to the request for comments contained in the Introduction of this publication.

Director, Aerospace Safety

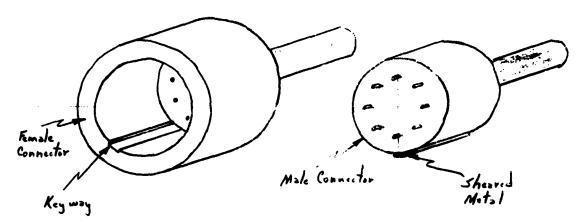
Not too long ago a man was injured and thrown approximately 10 feet when he attempted to plug in an electrical connector to a 440 volt power source. In examining the burned connector it was determined that mating had been attempted 180 degrees out of proper alignment. How was it possible to mismate an electrical connector designed with a keyway to prevent such things? One look at the key way on the damaged connector and several other good connectors told the story. The keyway was not deep enough and with a little wear the soft metal was sheared from the male ridge making it possible to easily mismate many of the connectors. This deficiency is illustrated in the sketch below:

- Design electrical keyways deeper and/or wider to prevent excessive wear.
- 2. Specify more than one keyway for each connector.
- 3. Design noncircular pins and/or place pins in an unsymetrical order.
- 4. Design a special guide pin or pins which would prevent misalignment.
- 5. Manufacture connectors from more durable metal which will resist wear.

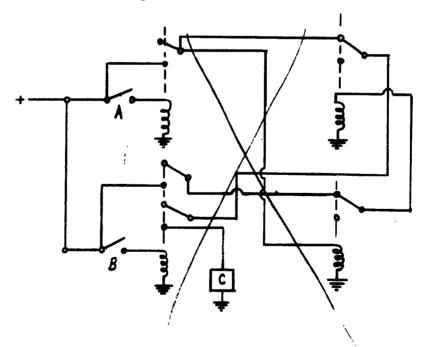
The schematic below represents a typical logic circuit which requires the sequential closure of first switch "A" and the switch "B" before voltage can be applied to component "C".

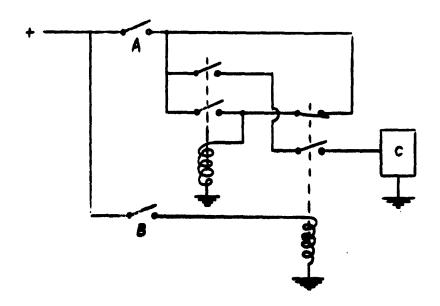
Sequential Multi-Switch Operation for Critical Circuits

The schematic below represents a typical logic circuit which requires the sequential closure of first switch "A" and the switch "B" before voltage can be applied to component "C".

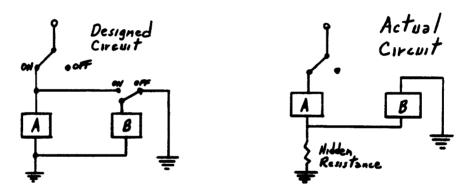
Current Leakage through Multiple Ground Contacts

When component "A" was activated during flight of a cruise missile, component "B" was inadvertently actuated and the missile was destroyed. Subsequent analysis indicated component "B" had been energized by ground leakage current caused by the existence of a "hidden" or unintentional resistance between the ground contact and the actual ground.

A fix was made by use of a common ground.
